SUBJECT: Site Assessment Report: General Die Casting Corp.
Detroit, Wayne County, Michigan
TDD # T059012014

**SITE ASSESSMENT REPORT
FOR
GENERAL DIE CASTING CORP.
DETROIT, WAYNE COUNTY, MICHIGAN**

JANUARY 1991

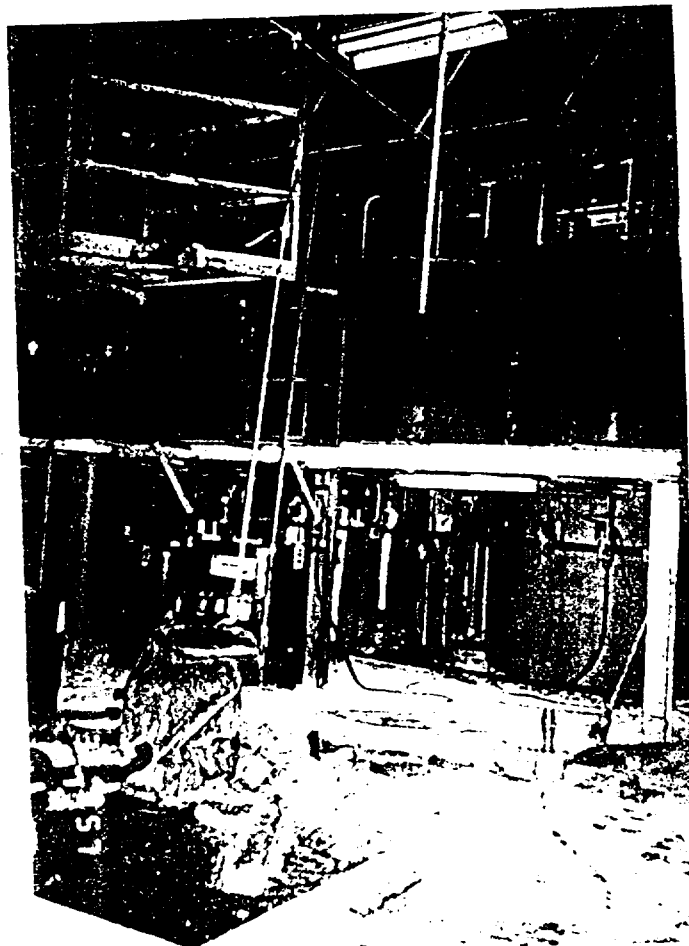
Site: General Die Casting
Photo No.: 06 Date: 12/20/90
Direction: Southwest
Camera: OLYMPUS INFINITY 35mm
Photographer: Rich Spehar
Subject: Waste treatment area
and residue left on floor.

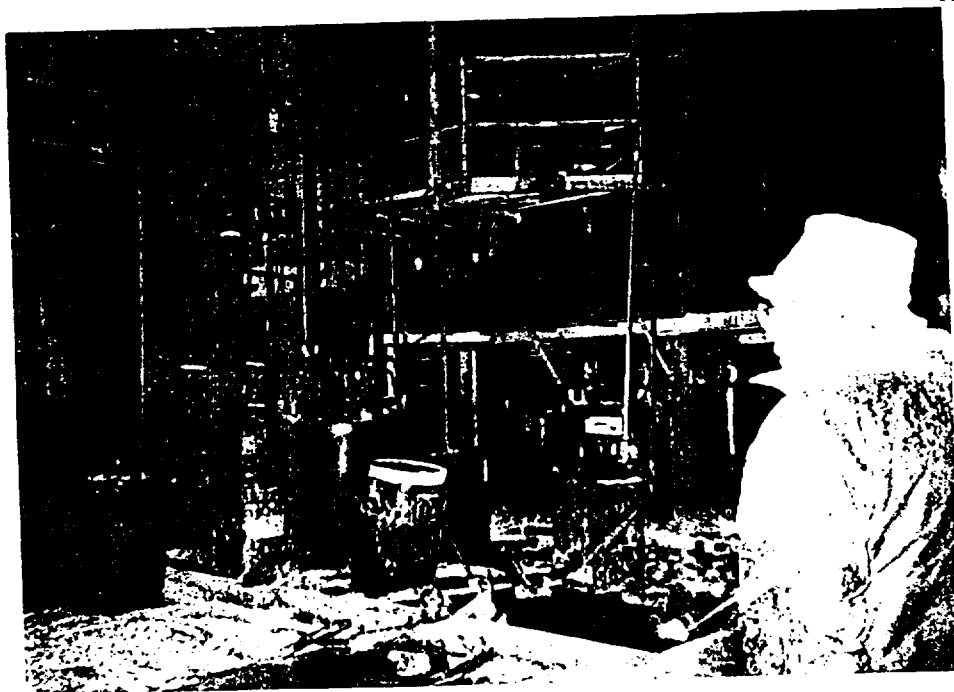
Site: General Die Cast
Photo No.: 06 Date: 12/20/90
Direction: Southwest
Camera: OLYMPUS INFINITY 35mm
Photographer: Rich Spehar
Subject: PRP surveys waste
treatment area.

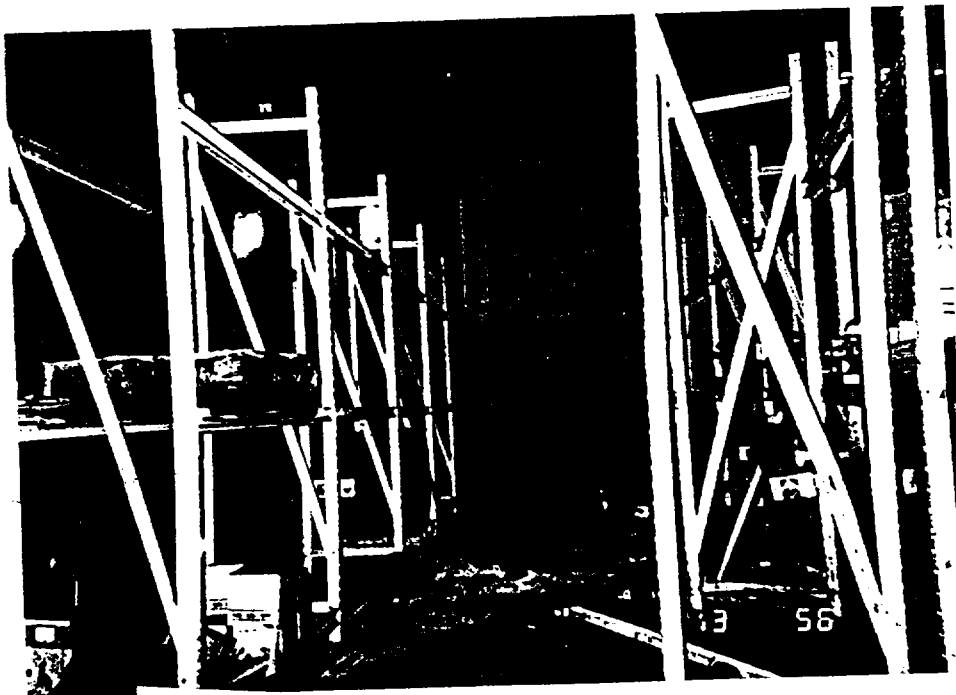
Site: General Die Cast
 Photo No.: 07 Date: 12/20/90
 Direction: West
 Camera: OLYMPUS INFINITY 35mm
 Photographer: Rich Spehar
 Subject: Chemical storage area.

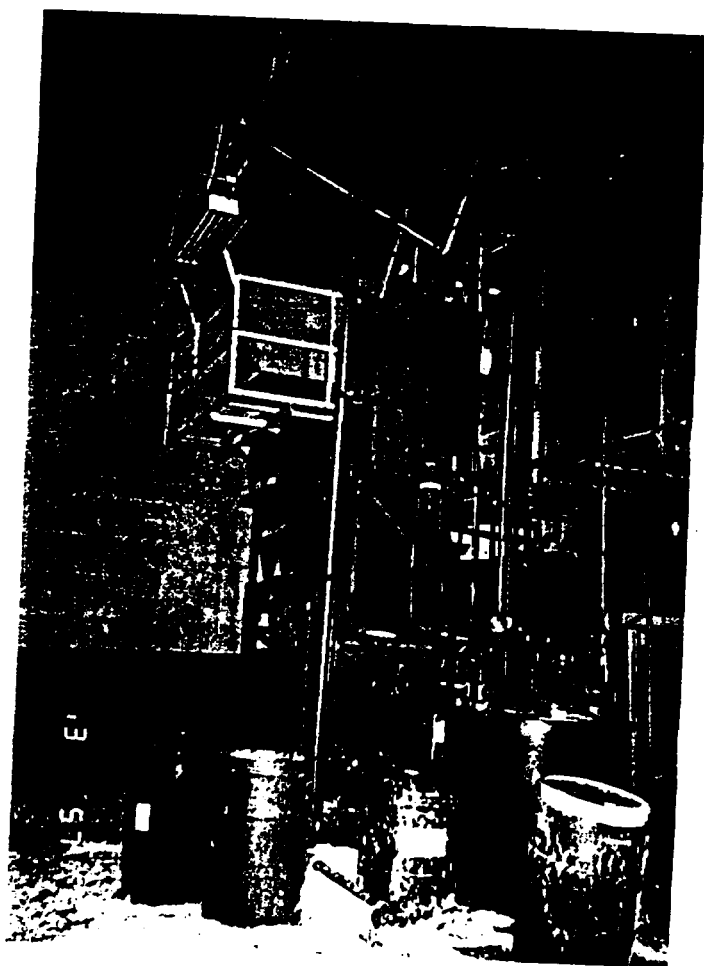
Site: General Die Casting
 Photo No.: 10 Date: 12/20/90
 Direction: South
 Camera: OLYMPUS INFINITY 35mm
 Photographer: Rich Spehar
 Subject: Drums and residue in
 waste treatment area.
